**Customer:**  
YCC #76

**System:**  
Main sanitary sewer system  
servicing 3 building  
(Over 1000 units)

## Problem

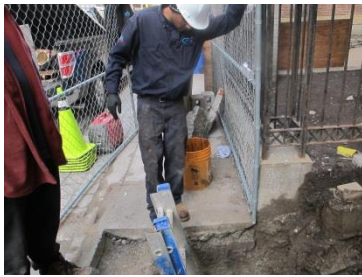
The 12" sanitary sewer running under the parking garage and into the streets was falling apart. We could see the collapsed pipe through a pit in the garage. Some storm drains in the same garage were also victim of collapsed joints, when it rains it pours!!

CPL installed a structural liner throughout the drainage system to restore the cast iron pipes and renew the structural integrity of the system. During the process CPL had to create a bypass to control the steady stream of water. This proved to be a highly technical job which was completed with perfection by the CPL crew.
