Customer:
Unilever Canada

System:
Sanitary System with
Constant Water Flow

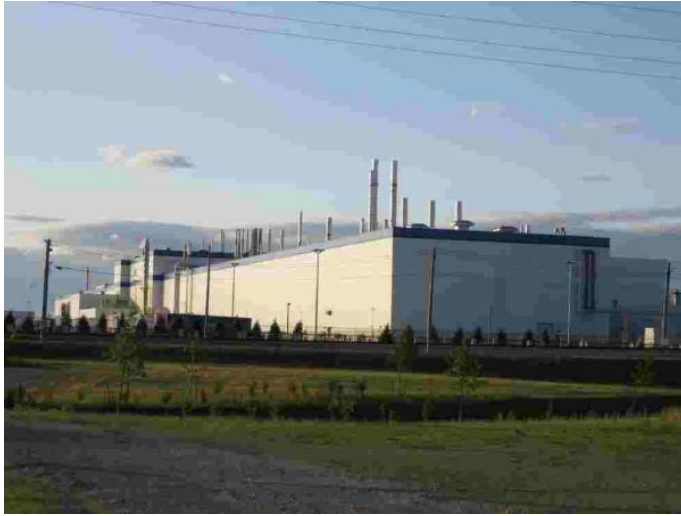
A section of 10" pipe shifted due to large transport trucks driving back and forth on a daily basis. The shift in pipe was causing blockages and flooding on the factory roadway and excavation was not an option!

CPL was called upon to create a bypass for the continuous water stream in the 10" pipe, the bypass had to safely carry water to a different location while the CPL crews cleaned the pipe and installed their structural pipe liners to even out the shift and eliminate the problem sanitary pipe.
