Customer:
WCC #72

System:
HVAC System fitted with steel pipe

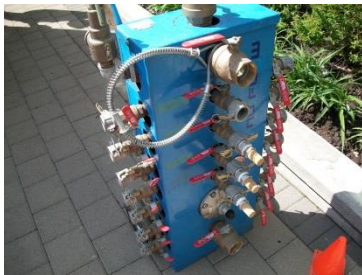
Erosion and heavy corrosion was leaving off the pipes and causing the coils within the units to get plugged up, decreasing flow and in turn decreasing the heating and cooling effects.

CPL was chosen over multiple bidders to carefully execute this diverse project. CPL coated the steel risers eliminating the leaching that was causing low flow. Later that year the building was retrofitted with new coils enhancing the efficiency of the HVAC system.
