Customer:
High Rise Condo

System:
Galvanized Cold Water Risers

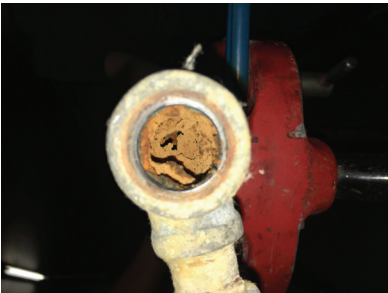
This high-rise building in Toronto High Park area was built in the 1960's and used galvanized pipes for their domestic water distribution. All the galvanized water pipes in the building were some areas showed to have 60% buildup of calcium and rust, most people would think that these pipes are at the point of no return.

The pipes were cored with specialty small diameter snakes to remove all debris from the pipe walls, following the snaking techniques a potable water approved solution was added to the pipe to further break up the calcium. Finally, CPL performed their abrasive cleaning techniques to the pipe interior bringing it to a perfect finish for epoxy lining.

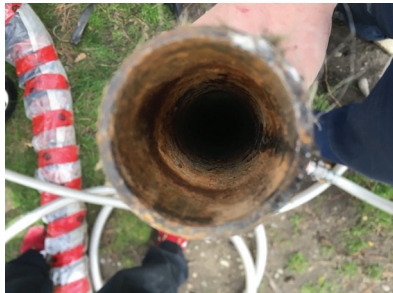
After Cleaning
